TECHNICAL TIP

Rover 75 / MGZT
Petrol Derivatives

No: TBX0501

FUEL PRESSURE – LITTLE OR NO FUEL PRESSURE

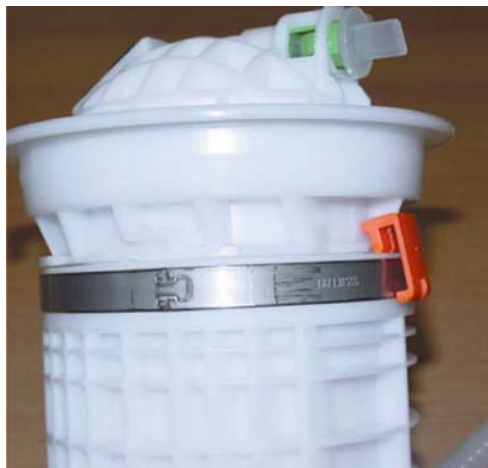
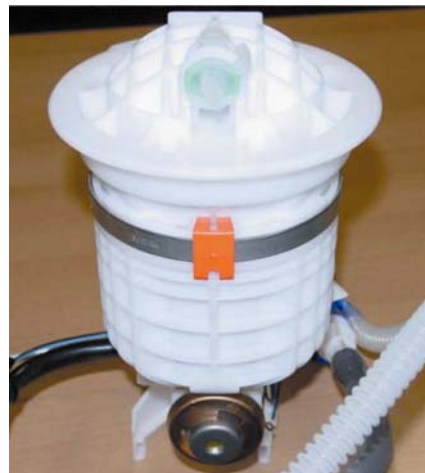
A number of vehicles have experienced problems arising from low or non-existent fuel pressure leading to an engine non-start condition. It is possible that the lack of fuel pressure may be down to the fuel filter assembly coming apart. Previously this would have necessitated a new fuel filter assembly to be fitted.

1. Remove the fuel filter housing in accordance with the repair operations manual. Please pay particular attention to the fuel safety warnings.
2. Inspect the upper and lower section of the filter to ensure they are fully locked together.
3. If required relock the housing as necessary.
4. Fit new locking clip. Part No WJC000230, ensuring the centre of the clip locates around the strengthening web as shown below.
5. Refit the fuel filter housing in accordance with the repair operations manual.

NOTE: If a new fuel filter assembly is fitted or the assembly is dismantled as part of a repair it will also be necessary to fit a retaining clip. There are no plans to modify the new assemblies.
